# NEW PRODUCT!

Announcement Number: **S06162601**

## 8L90-ACCUM

### 1-3-5-6-7 Accumulator Piston Kit

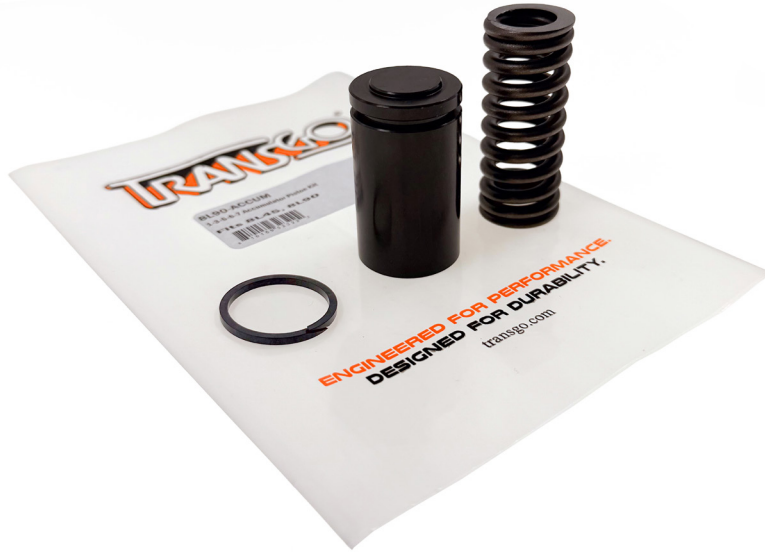
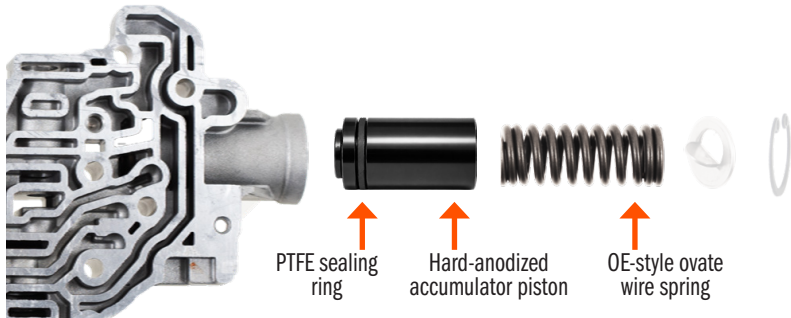
This kit upgrades the accumulator circuit with a hard-anodized aluminum piston fitted with a PTFE sealing ring. PTFE conforms better to irregularities, including bores worn slightly oval. PTFE is also more tolerant of bore glazing and uneven wear that can quickly damage or compromise a rubber seal.

Also included is a calibrated OE-style ovate wire spring. The TransGo spring design matches the factory spring style maintaining the intended accumulator action while reducing spring stress for a durable, lasting repair.

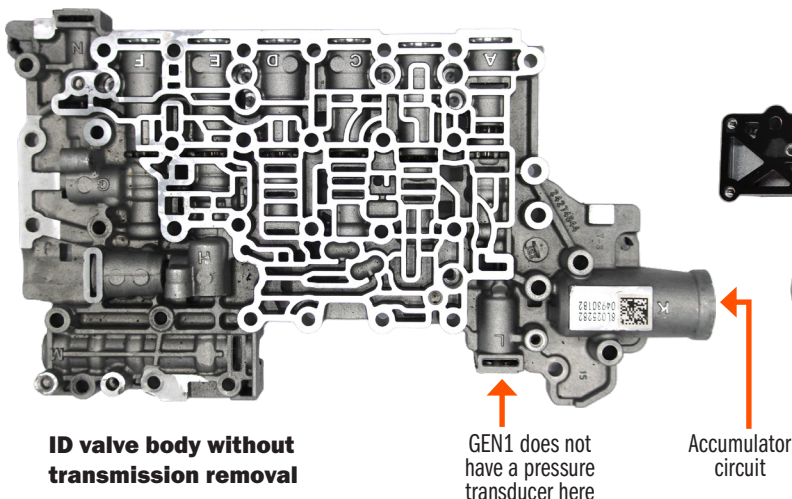
### GEN1 (2015-2023)

**ID valve body without transmission removal**

GEN1 does not have a pressure transducer here

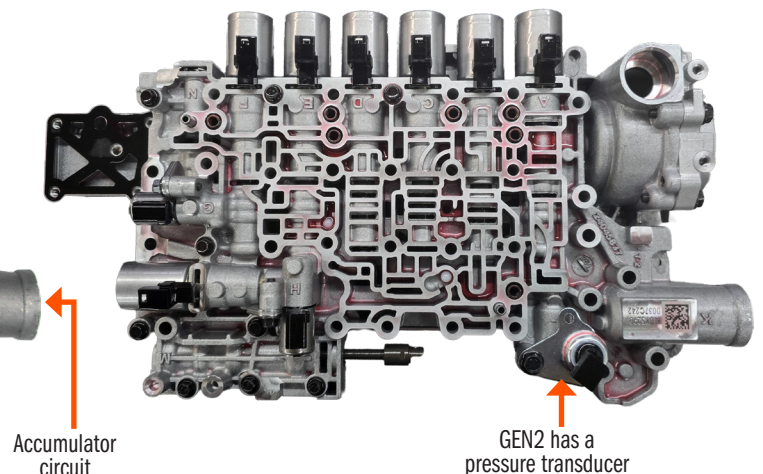
### GEN2 (2022-on)

GEN2 has a pressure transducer
