Announcement Number: S12032401

Drop-in fix for accumulator bore wear causing 4-5-6 clutch failures and shift complaints.

Part number: 6T70-ACCM-G2
4-5-6 Accumulator Piston Kit
Fits 6T70, 6T75, 6T80 GEN2 2013-on

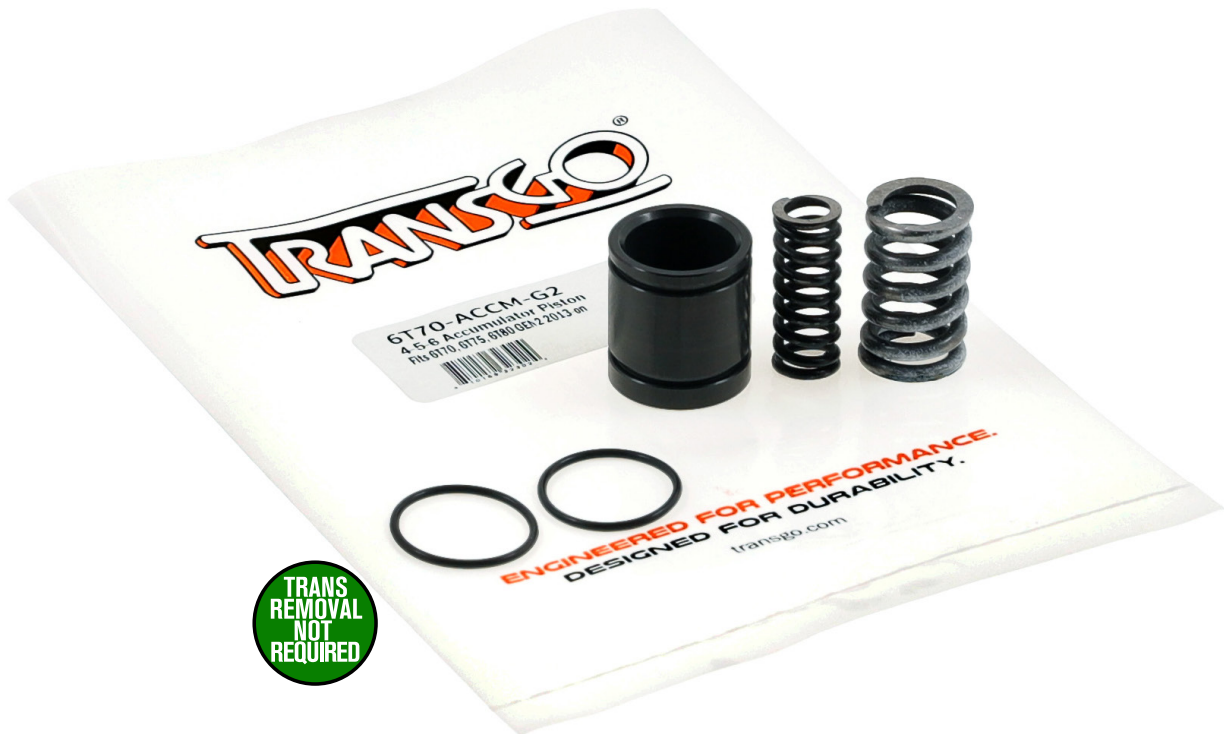
The 4-5-6 accumulator piston plays a vital role in the application of the 4-5-6 clutch. When wear occurs in the piston bore, it creates a loss of 4-5-6 clutch apply pressure. The loss of apply pressure leads to clutch slippage which can cause harsh or delayed shifts, shift flares, ratio codes and clutch failure.

The reengineered piston has two strategically placed O-rings to prevent further piston-to-bore contact/wear, in addition to renewing the 4-5-6 accumulator circuit integrity and salvaging a worn valve body.

- Slips in 4th, 5th or 6th gears
- Burnt 4-5-6 clutches
- Dual sealing design prevents piston-to-bore contact/wear
- Salvages a worn valve body
- Solenoid performance and or ratio codes
